INFORMATION HANDOUT

For Contract No. D01-0B3604

File: 01-HUM-36-PM 35.5-40.5
EA: 01-0B3601
EFIS ID: 0112000120
Storm Damage Repair

Subject: Geotechnical Design Recommendations, Dinsmore Slipouts/Sink

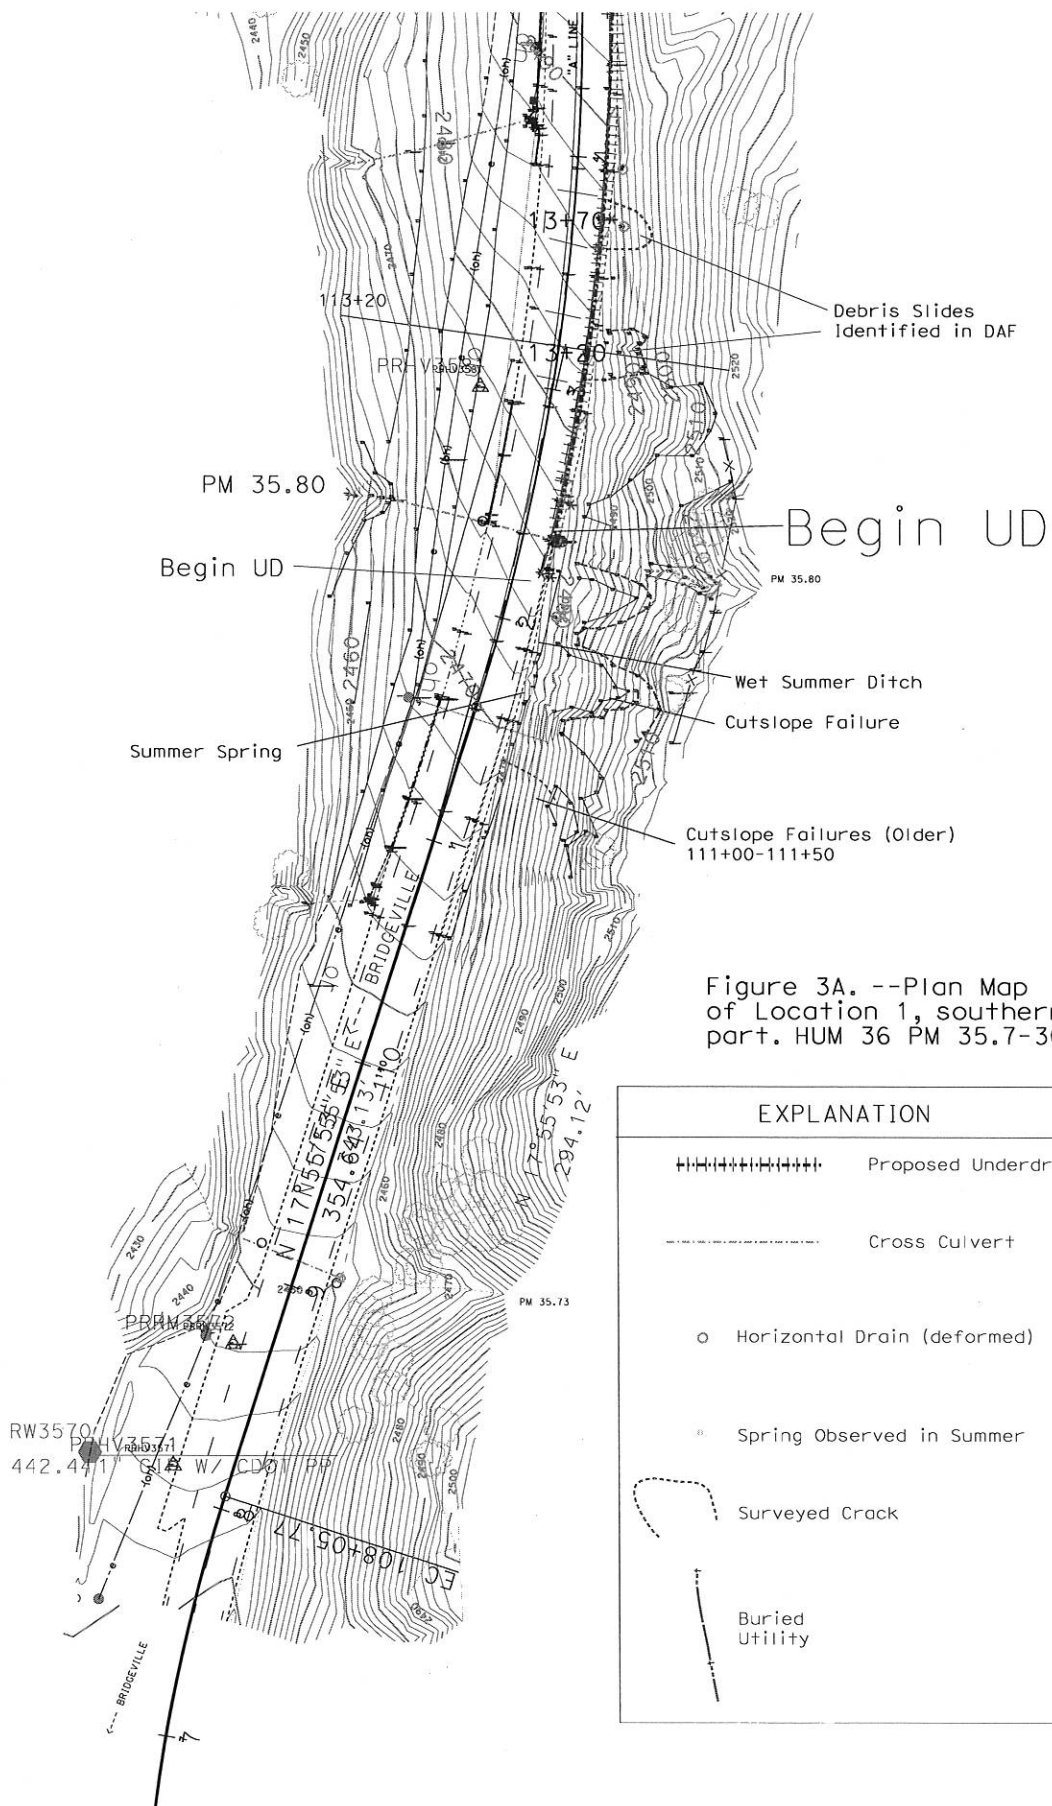
Figure 3A. --Plan Map of Location 1, southern part. HUM 36 PM 35.7-36.

In addition to the two debris slides shown in the DAF, which are centered at Station 113+20 and Station 113+70, we observed debris slides farther west. These include an active debris slide between Station 111+65 and Station 112+00, and debris slides of variable ages from Stations 111+00 to Station 111+50, from Stations 112+00 to Station 112+31, and from Station 112+52 to 113+00 (Figure 3A).

We observed eight active seeps where groundwater exits from the cutslope in the summer. The seeps are located between Station 111+70 and Station 115+00. We also observed several dry, deformed horizontal drains, which are shown on the plan map (Figure 3A). During late summer (July and August, 2012) we observed flowing and standing water in the inboard ditch to the west of Station 115+00.

1. Construct a 20-foot deep underdrain between PM 35.80 and PM 35.86 and between PM 35.86 and PM 35.95 (Figures 3A and 3B). Typical underdrain design details are shown in Figure 8.
2. Install 150-foot-long "horizontal" drains on 20-foot centers between Station 115+00 and PM 35.80. A typical section and design details for horizontal drains are shown in Figure 9.

The horizontal drains should be drilled approximately 4 feet above the base of the cut and extend 100 feet into the cutslope. The drains should be drilled at an uphill gradient of 5%. The drains should consist of 90 feet of slotted plastic pipe and 10 feet of solid plastic pipe. We recommend the largest slot width of 0.05 inch for the slotted pipe. Please refer to Figure 9 and the Standard Specifications Section 68-3 for the design and construction details for horizontal drains.

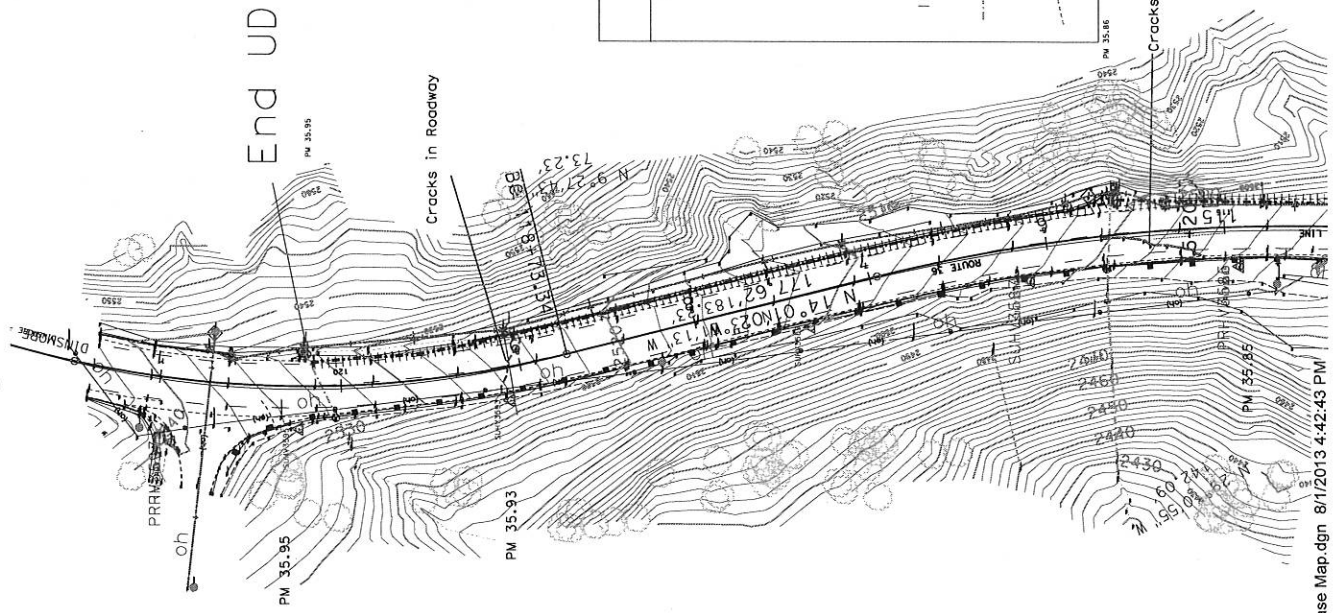
Figure 3B. --Plan Map of Location 1, northern part. HUM 36 PM 35.8-36.0

During 2012 and 2013, we observed cracks in the roadway between Stations 115+00 and 115+70 and near Station 119+00 (Figure 3B). The full extent of the original damage was not visible, because the site had been paved twice since the storm damaged occurred.

We mapped and surveyed the cracks in the roadway. We measured rag-tape topographic sections of the embankment and the roadway near PM 35.86, observing hummocky topography and an additional scarp on the embankment between Station 114+75 (PM 35.85) and Station 119+20. We also measured topographic sections through the two debris slides on the cutslope that are shown in the DAF.

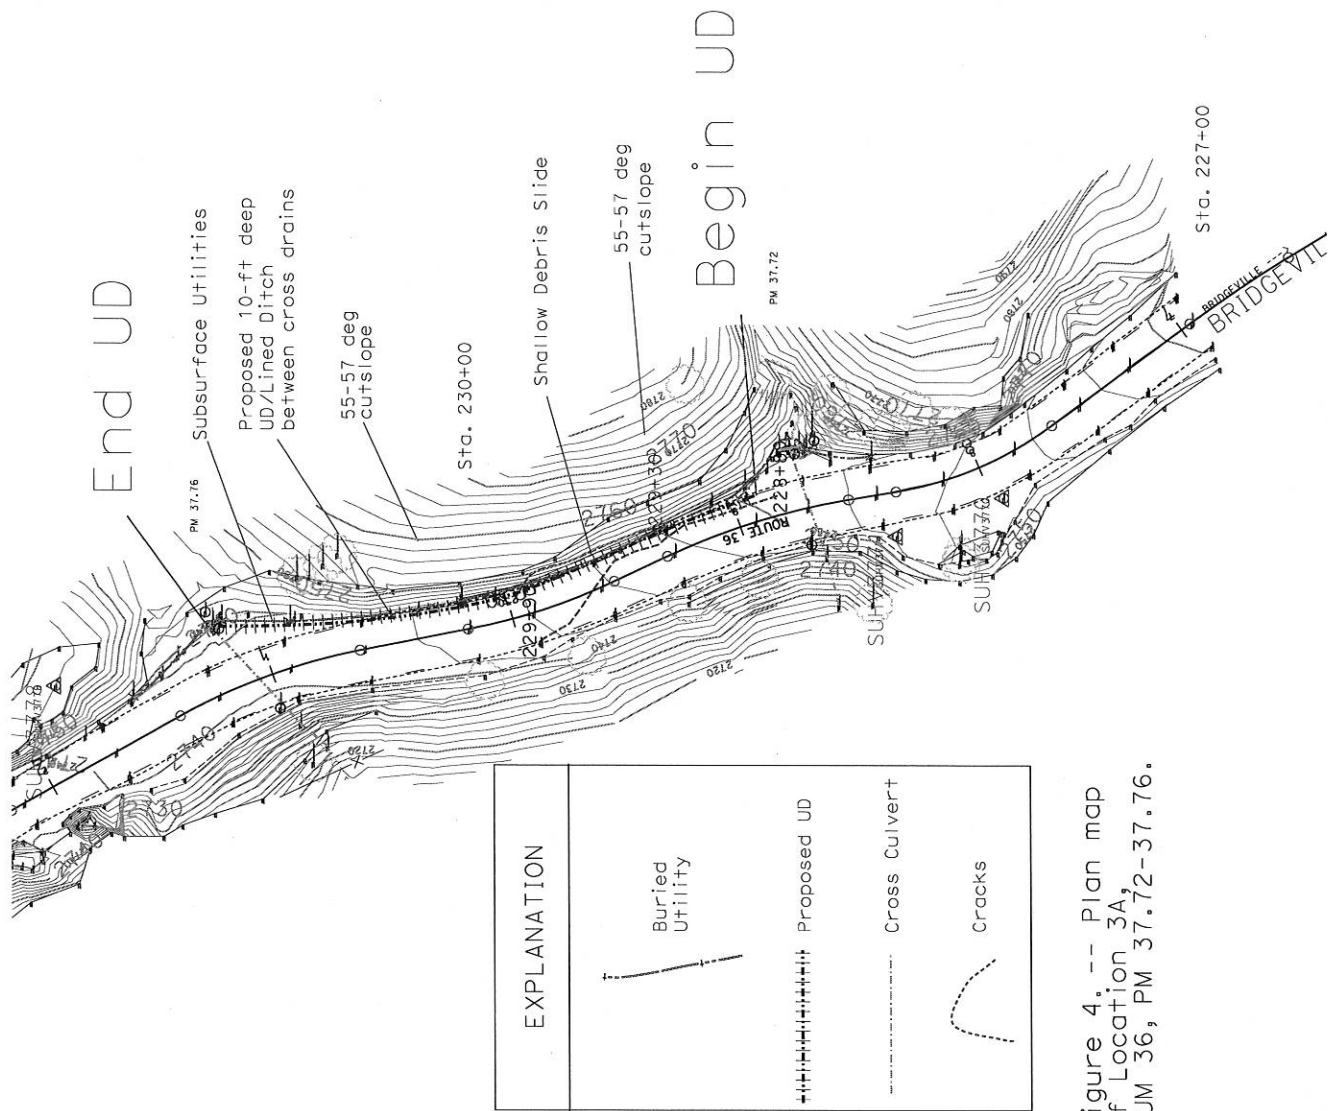
Figure 4. -- Plan map of Location 3A, HUM 36, PM 37.72-37.76.

We surveyed cracks in the asphalt between Stations 228+20 and 229+90. The cutslope at Location 3A is 0.65:1; we observed shallow debris slides between Station 229+30 and Station 229+90. The cutslope exposes silty gravel with sand (GM) and clayey gravel with sand (GC). We anticipate this material will be encountered during excavation for the proposed underdrain.

4. Construct a 20-foot deep underdrain between PM 37.72 and PM 37.76 (Figure 4). Do not cut into the existing cutslope.

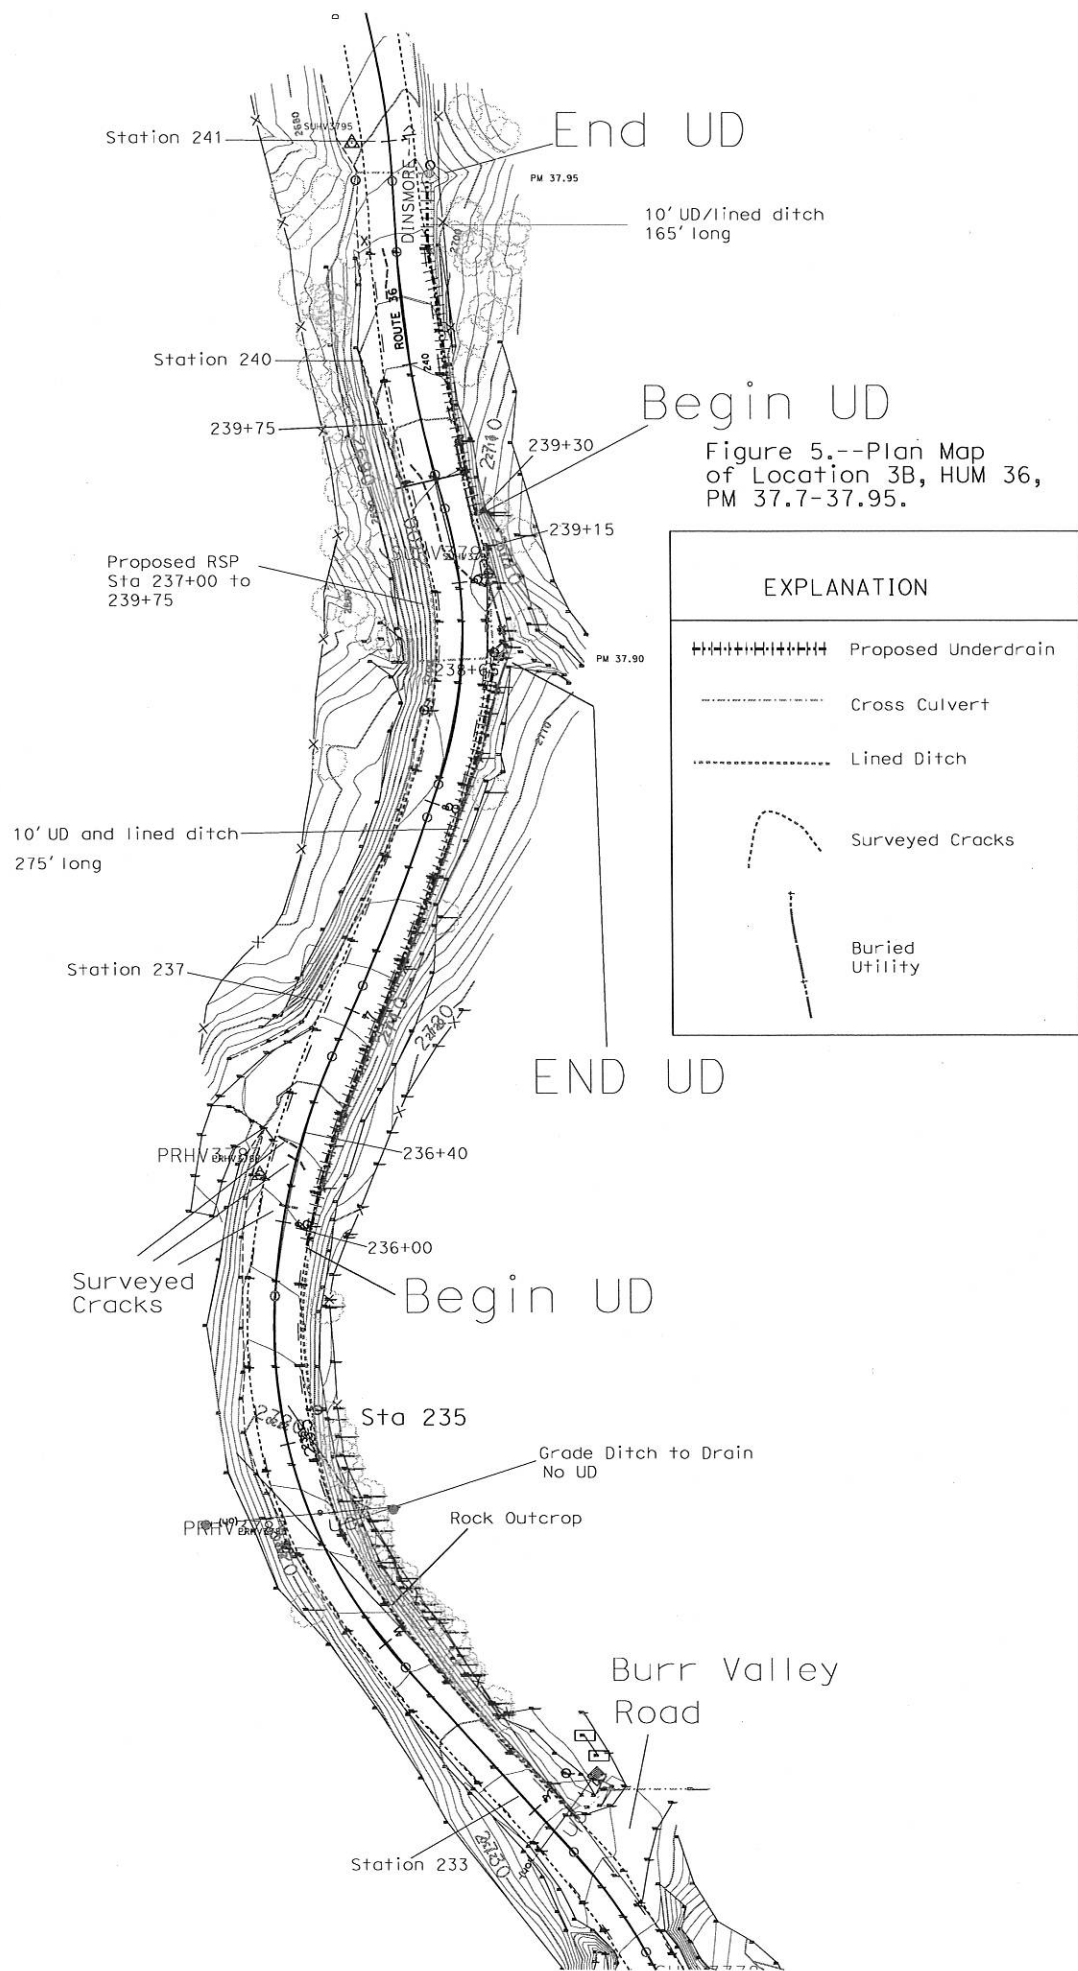
Figure 5.--Plan Map
of Location 3B, HUM 36,
PM 37.7-37.95.

In 2013 we observed cracks in the roadway between Stations 236+00 and 236+40. The DAF indicates this was an area of deformation in March 2011. In 2012 and 2013, we noted cracks extending from the right side of the roadway at Station 239+00 into the westbound lane to Station 239+60.

During July of 2012, we observed that the inboard ditch was moist from Station 235+10 eastward, and wet from Station 238+20 eastward to PM 37.90 (Figure 5).

5. Construct 10-foot deep underdrains as follows: between Station 235+90 and PM 37.90, between PM 37.90 and station 239+15, and between Station 239+30 to PM 37.95.

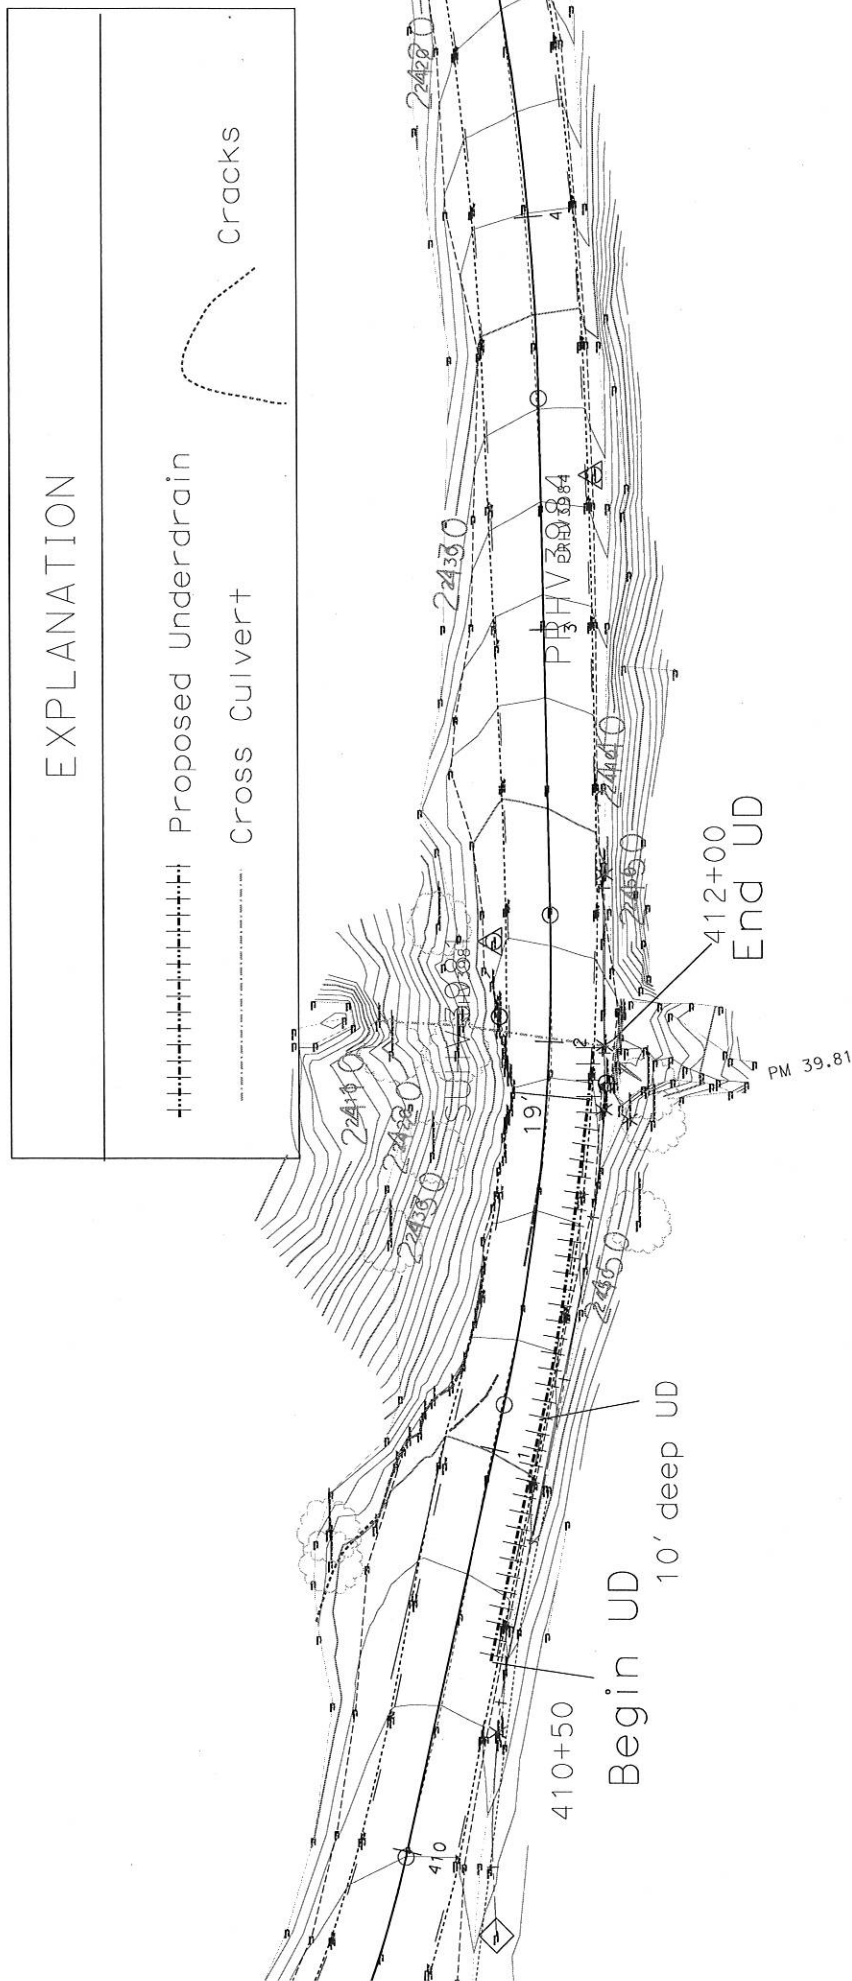
Figure 6 -- Plan Map of Location 4, HUM 36, PM 39.81

We investigated Location 4 during July and August of 2012, and on February 26, 2013. We observed cracks in the unpaved turnout and westbound lane for a length of 115 feet (Figure 6).

In August 2012, we observed stream flow infiltrating beneath the culvert inlet. A large area of embankment erosion is visible at the culvert outlet at PM 39.81. According to As-Built files, a new pipe was placed at this site in 1992-1993. Below the roadway, we observed a functioning outlet. We saw no evidence of water seeping around the outside of the pipe. The outlet pipe lies between bedrock and overlying fill; it emerges from the slope as a "shotgun" culvert outlet. We observed a dry stream bed from the outlet pool to the Van Duzen River in June 2013. The stream water had infiltrated into the subsurface.

8. Construct a 10-foot deep underdrain from Station 410+50 to the cross drain at PM 38.81 (Figure 6).

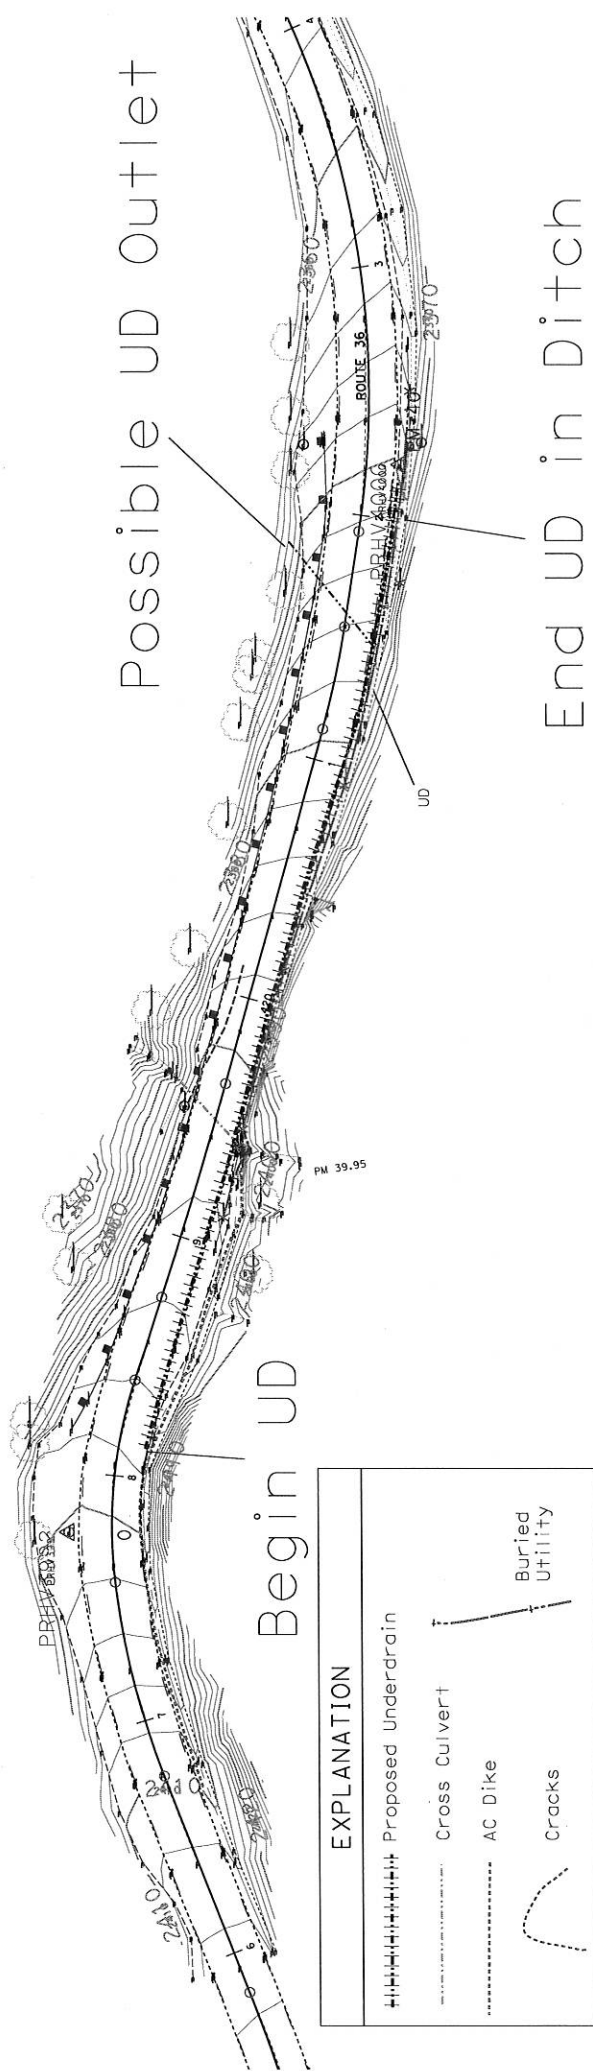
Figure 7. --Plan Map of Location 5, HUM 36, PM 39.9 - 40.0.

We investigated Location 5 during July and August of 2012 and during the on-site PDT meeting on February 26, 2013. We observed cracks for a distance of approximately 70 feet adjacent to the guardrail (along the line of MBGR posts) from the cross culvert at Station 419+55 to Station 420+25. In February of 2013, cracks had developed in the westbound lane from Station 419+70 to Station 420+12.

During August 2012, we observed flowing water in the inboard ditch between Station 417+50 and PM 39.95, and between Station 422+00 and PM 40.0 (Figure 7). We observed water seeping from the cutslope at Station 422+20 and water standing in the inboard ditch at PM 40.00.

9. Construct a 10-foot deep underdrain from Station 418+20 to the cross drain at PM 39.95 (Figure 7).

Construct a second 10-foot deep underdrain from Station 418+20 to outlet either to a new underdrain outlet, at approximately Station 421+55, or in the inboard ditch within the project limits.
